2016 CBC Applicable Cross-Laminated Timber (CLT) Sections

All Decked Out¹

By Joseph W. Lstiburek, Ph.D., P.Eng., Fellow ASHRAE

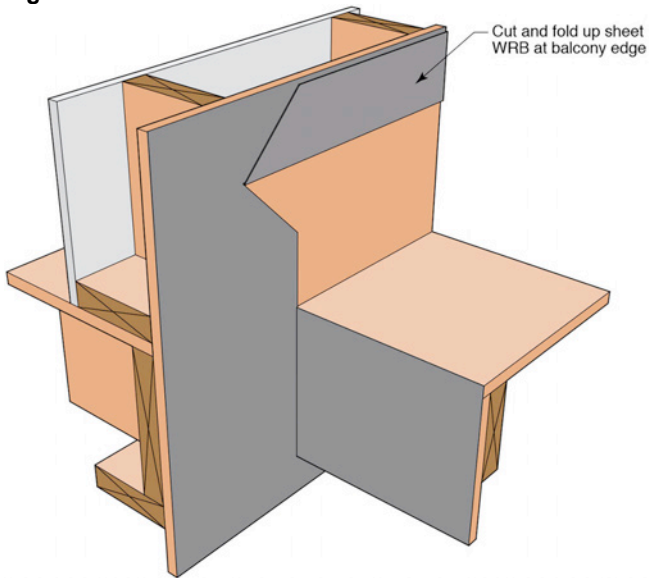
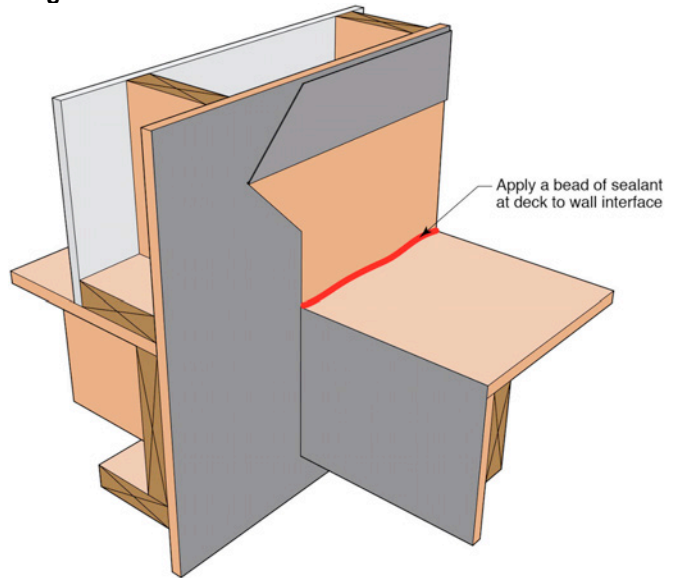
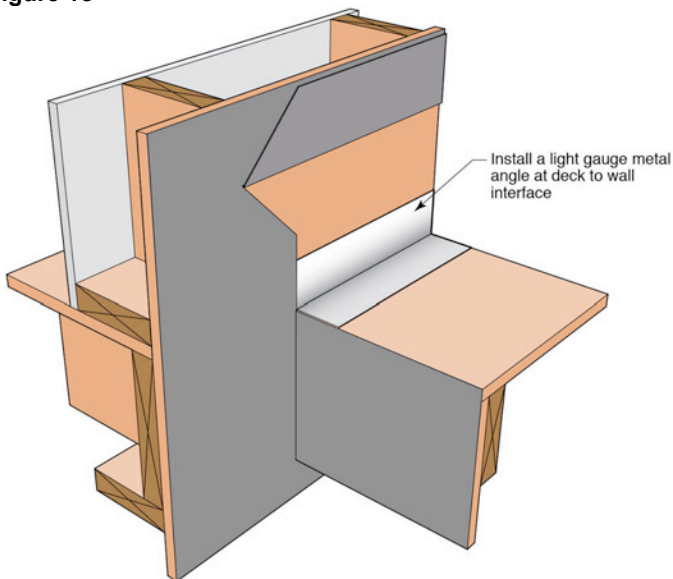
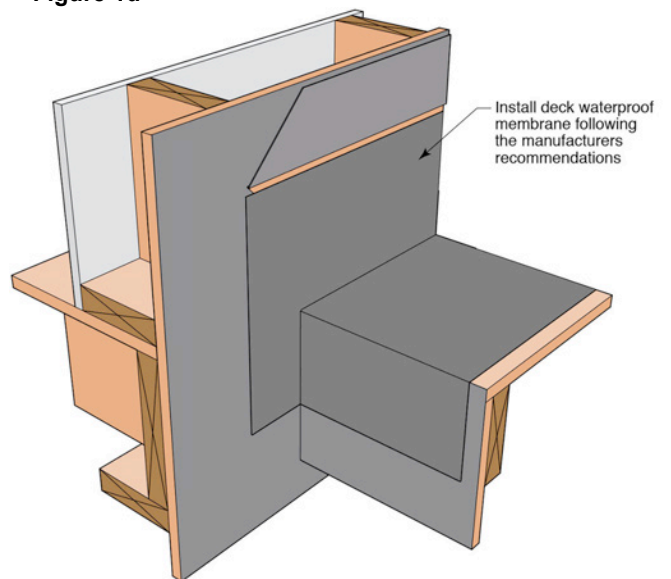
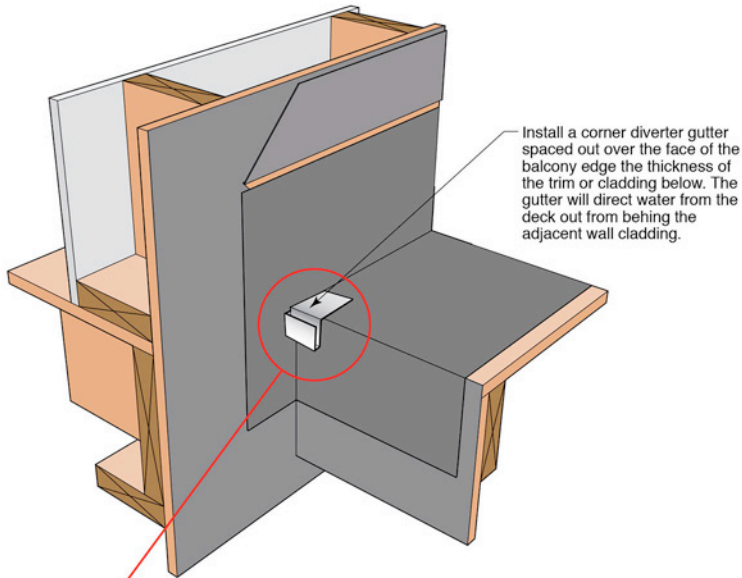
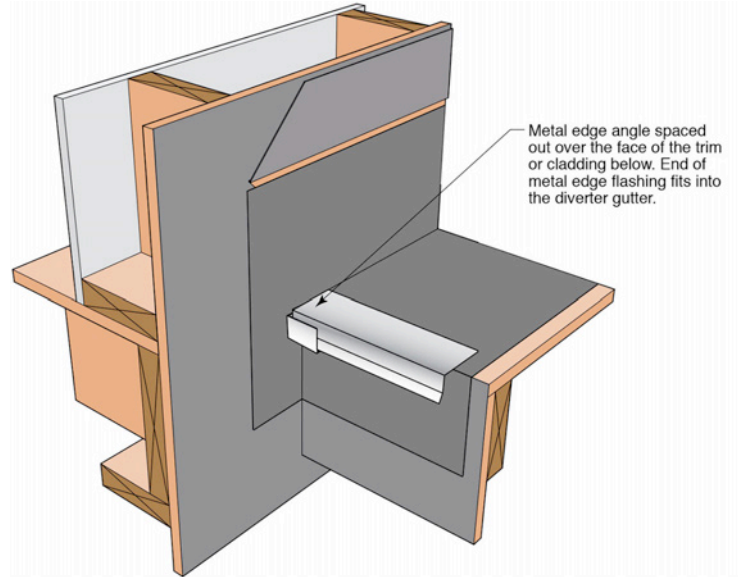
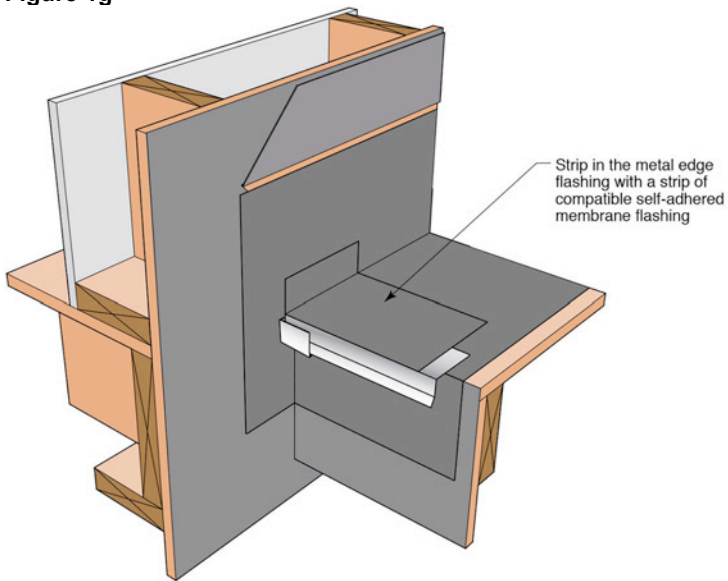
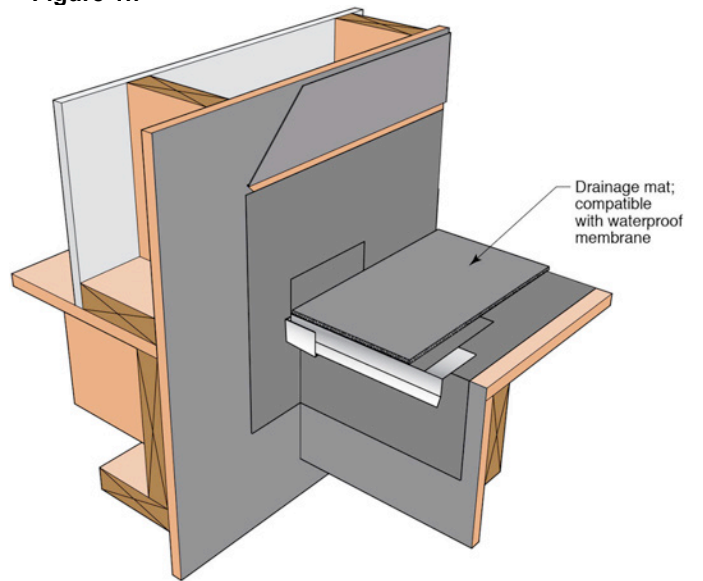
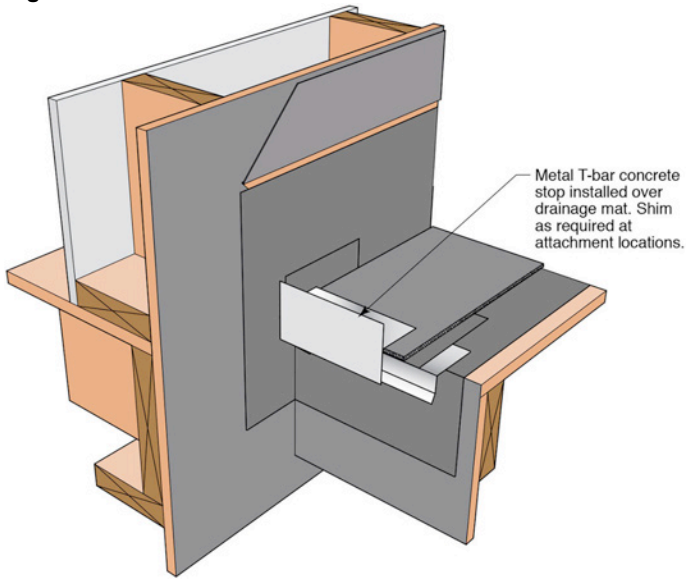
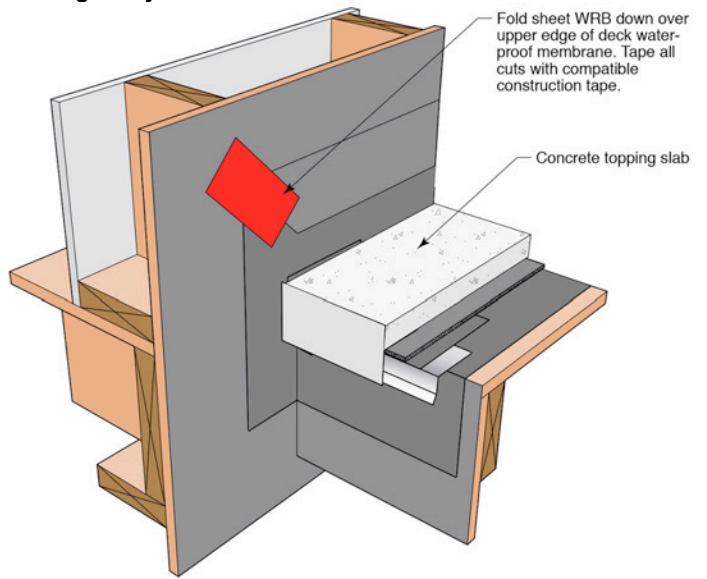
Figure 1: Intersection of a Balcony Edge Perpendicular to a Wall—The details remain substantially the same if a fluid applied water control layer is used or a fully adhered sheet membrane water control layer is used.

It gets even more interesting when architects push the balconies outwards and inwards and locate them in corners. The waterproofing of the balcony deck needs to connect to the waterproofing of the walls. Remember the first principle of building enclosures? Connect the water control layer of the wall to the water control layer of the roof and to the water control layer of the foundation? Well, a balcony is a roof that you walk on. The aesthetic complexity results in construction complexity. The detailing and execution of the detailing is a big deal. It is probably the most difficult thing to get right and probably the most important thing to get right.

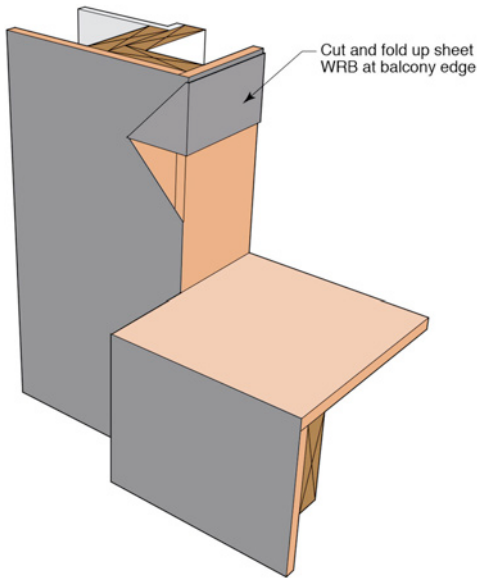
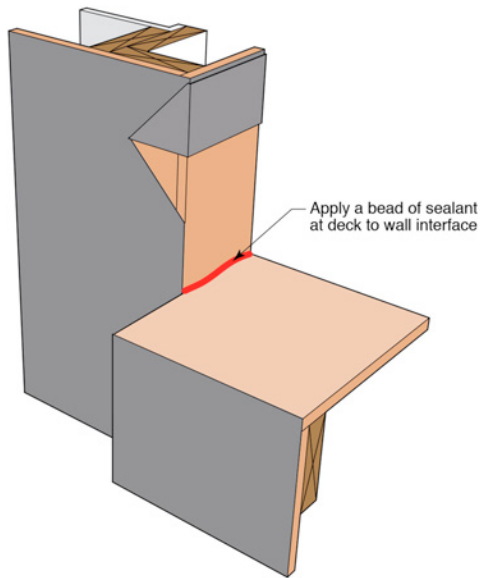
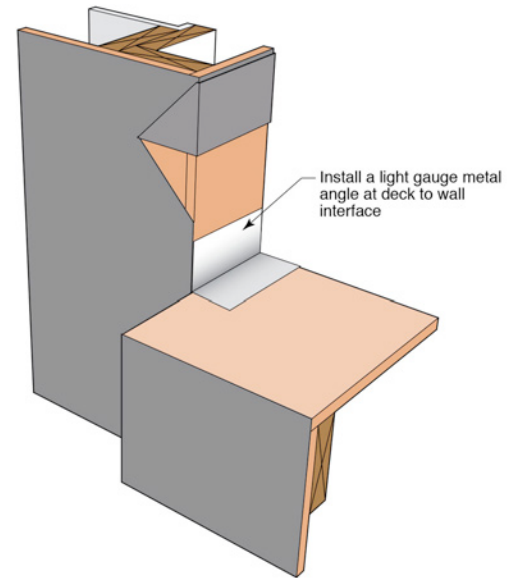
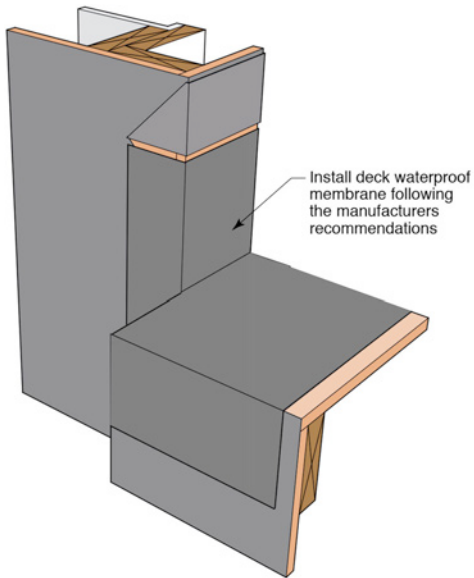
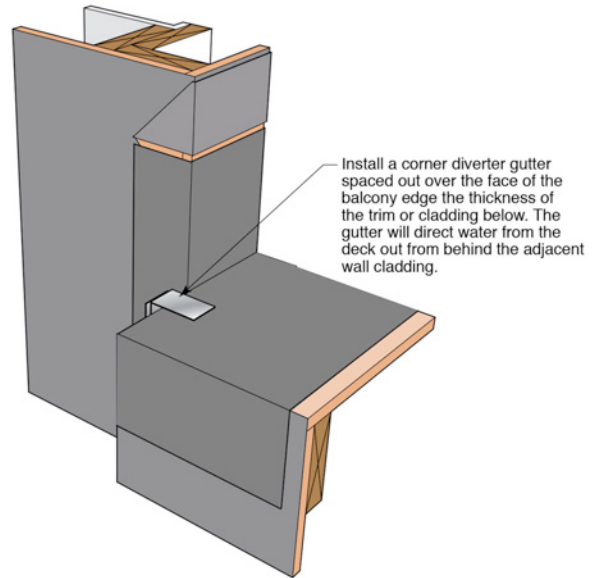
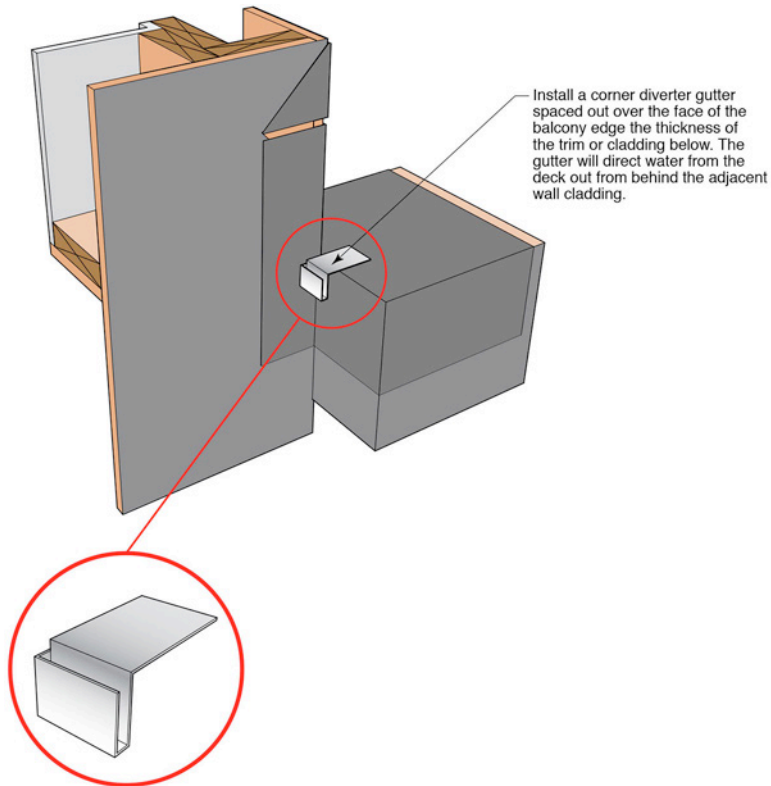
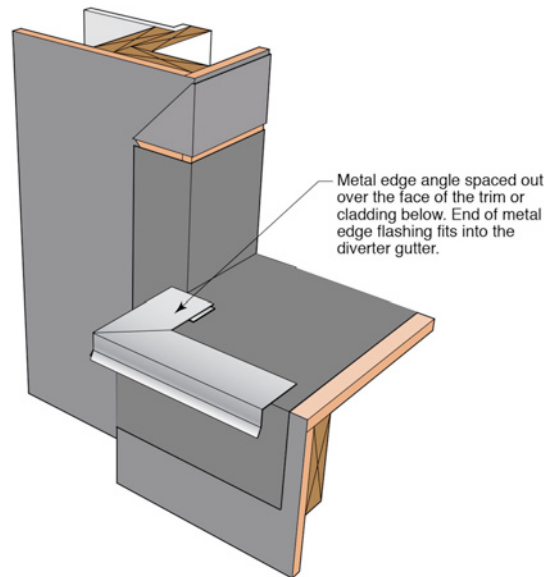
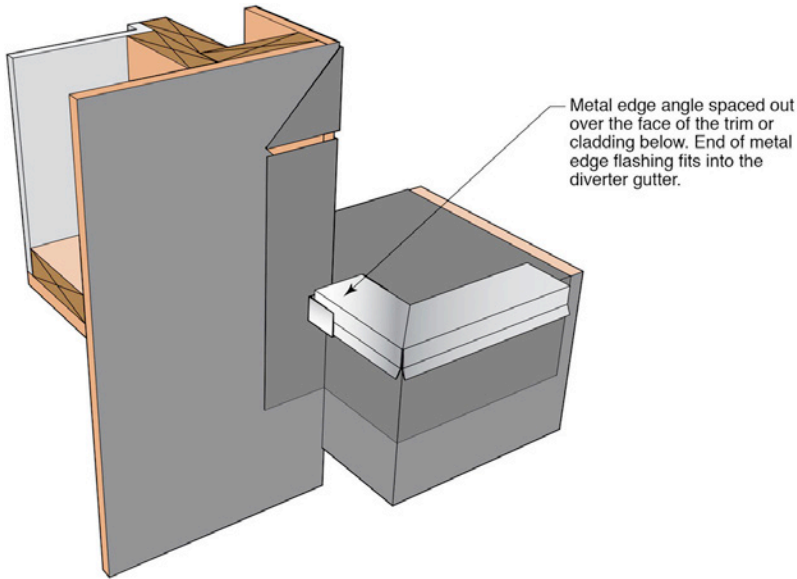
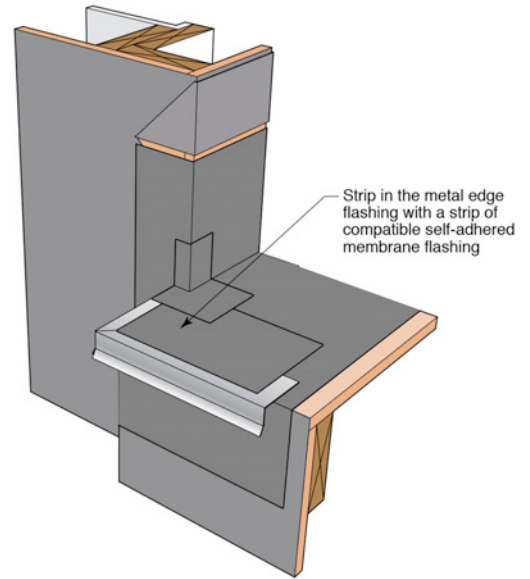
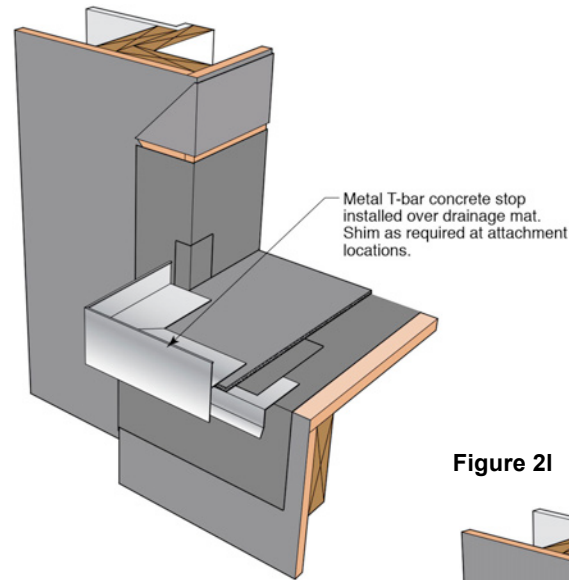
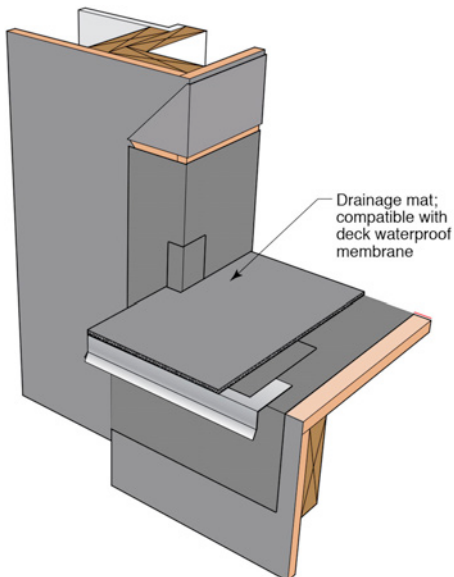
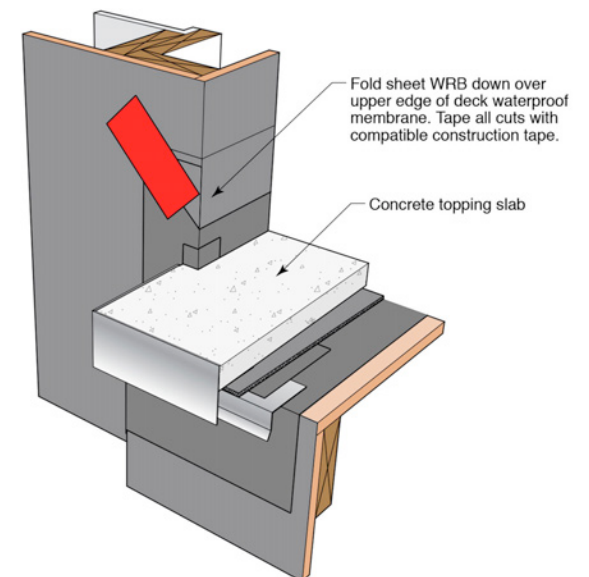
Figure 2: Intersection of a Balcony Edge Proud of a Wall—The details remain substantially the same if a fluid applied water control layer is used or a fully adhered sheet membrane water control layer is used.

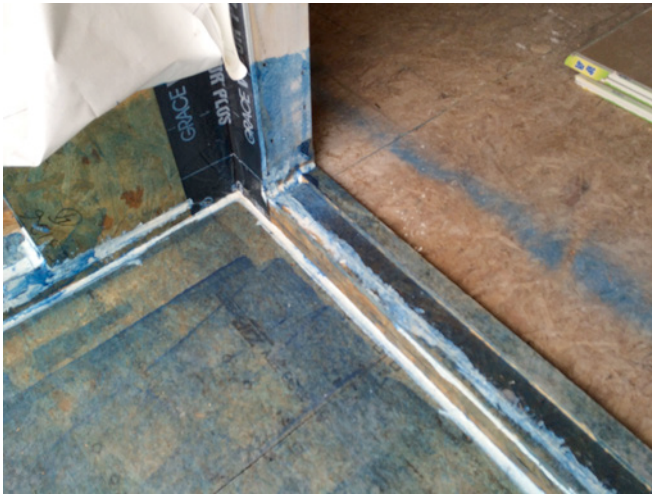
sheathing and the OSB wall sheathing. The primer's function is to facilitate adhesion of the waterproofing membrane. Also note the back dam support for the yet to be installed pan flashing in the rough opening for the balcony door.

Photograph 1: Sealant Joint—A sealant joint is installed at the perimeter of the balcony deck where it intersects the exterior wall. Note the primer application on engineered wood deck sheathing and the OSB wall sheathing. The primer's function is to facilitate adhesion of the waterproofing membrane. Also note the back dam support for the yet to be installed pan flashing in the rough opening for the balcony door.

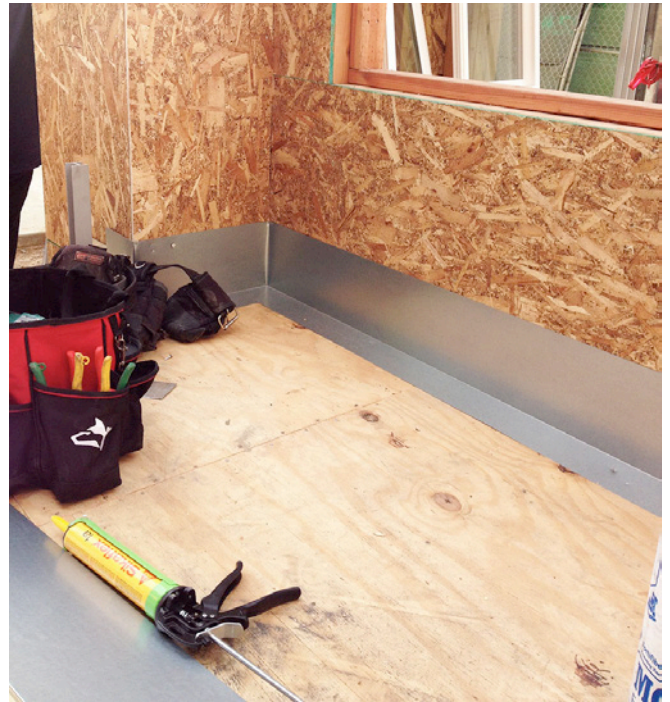
Photograph 2: Metal Angle—Note the use of plywood as the balcony deck surface. Plywood and engineered wood deck sheathing are typically both used interchangeably. However, adhesion of membrane waterproofing to engineered wood deck sheathing tends to be more difficult and primers become key to successful adhesion.

Photograph 2 shows the installation of a light gauge metal angle at the deck to wall interface. Note the use of plywood as the balcony deck surface. Plywood and engineered wood deck sheathing are typically both used interchangeably. However, adhesion of membrane waterproofing to engineered wood deck sheathing tends to be more difficult and primers become key to successful adhesion.

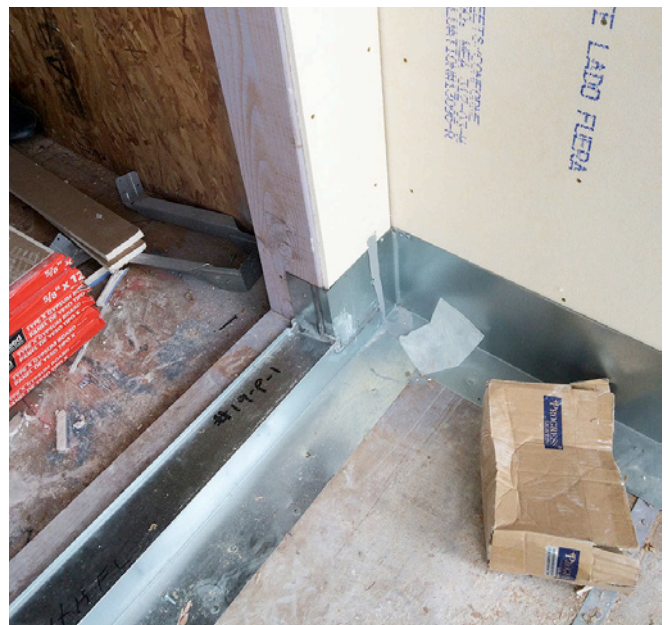
Photograph 3: Pan Flashing of Balcony Door—Note the back dam and end dam of the flashing for the balcony door. The back dam support for the pan flashing has not yet been installed. The back dam support protects the upstand of the back dam during the construction process.

Photograph 3 shows the pan flashing of the rough opening of the balcony door. Note the back dam and end dam of the flashing for the balcony door. The back dam support for the pan flashing has not yet been installed. The back dam support protects the upstand of the back dam during the construction process.

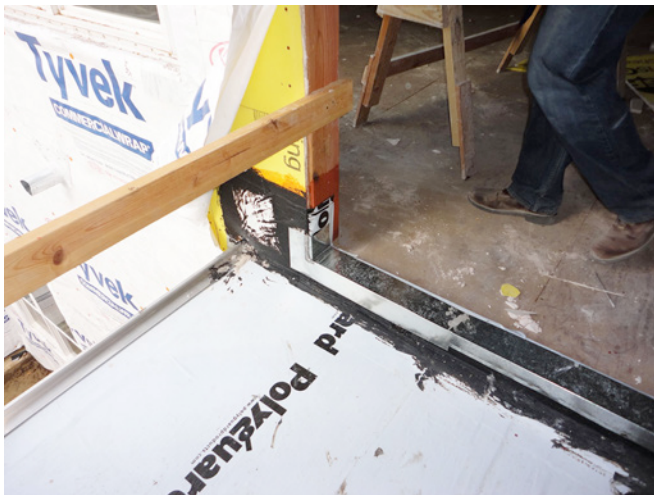
Photograph 4: Membrane Waterproofing—Additional metal flashing is installed over the waterproofing that is stripped into the pan flashed balcony door opening. This additional metal flashing protects the membrane waterproofing at the door opening.

Photograph 4 shows the installation of the membrane waterproofing. In this balcony installation an additional metal flashing is installed over the waterproofing that is stripped into the pan flashed balcony door opening. This additional metal flashing protects the membrane waterproofing at the door opening.

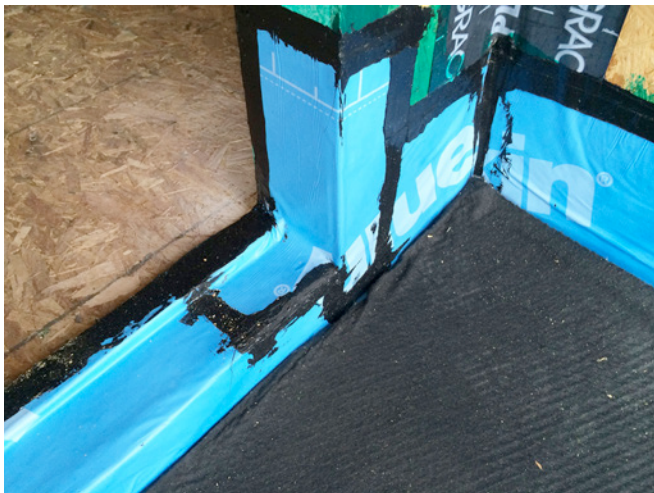
Photograph 5: Drainage Matt—Membrane waterproofing is stripped into the pan flashed balcony door opening. Note the drainage mat installed over the top of the membrane waterproofing. Also note the mastic application sealing the vertical portion of the balcony deck waterproofing membrane to the wall sheathing.

Photograph 5 shows the installation of membrane waterproofing stripped into the pan flashed balcony door opening. Note the drainage mat installed over the top of the membrane waterproofing. Also note the mastic application sealing the waterproofing membrane to the wall sheathing.

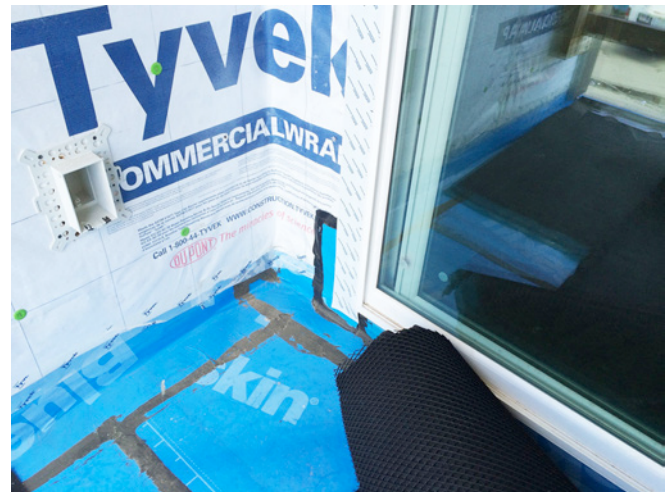
Photograph 6: Shingle Lapping—The water resistive barrier (WRB) is shingle lapped over the vertical portions of the membrane waterproofing. Also note the installation of the balcony door. A drainage mat is yet to be installed.

Photograph 6 shows the lapping of the water resistive barrier (WRB) over the vertical portions of the membrane waterproofing. Also note the installation of the balcony door. A drainage mat is yet to be installed.

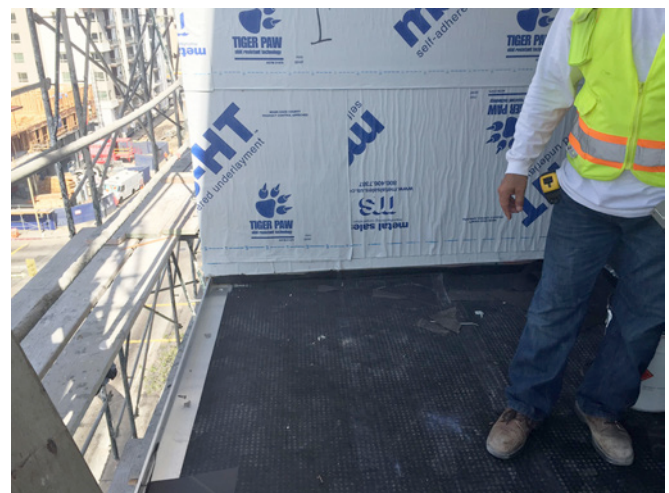
Photograph 7: Drip Edge and Drainage Matt—The water resistive barrier (WRB) is lapped over the membrane waterproofing. A drainage mat is in place as is the drip edge at the balcony edge.

Photograph 7 also shows the lapping of the water resistive barrier (WRB) over the membrane waterproofing. A drainage mat is in place as is the drip edge at the balcony edge.

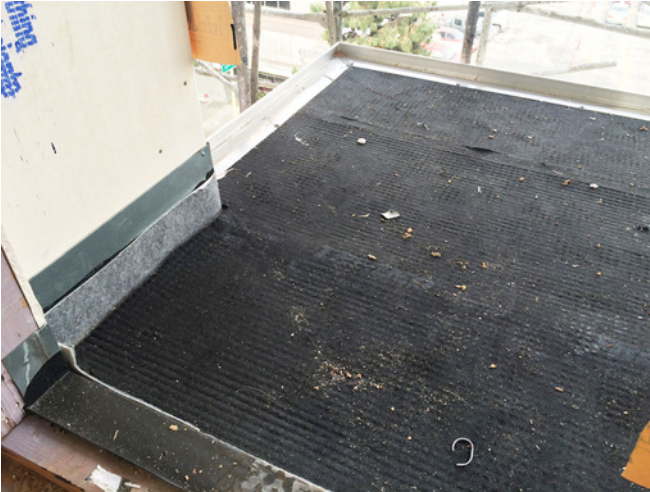
Photograph 8: More Drainage Matt—The vertical top edge of the perimeter balcony deck waterproofing membrane is yet to be stripped into the exterior wall sheathing with mastic.

Photograph 8 shows the installation of a drainage mat. The vertical top edge of the perimeter balcony deck waterproofing membrane is yet to be stripped into the exterior wall sheathing with mastic.

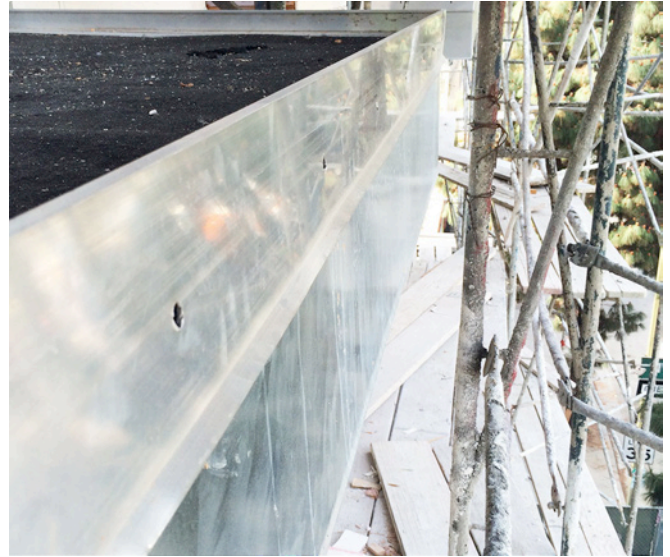
Photograph 9: Two Drip Edges—The upper drip edge sheds water flowing over the edge of the concrete topping. The lower drip edge sheds water from the drainage mat gap on the top of the waterproofing membrane under the concrete topping. This two-stage drip edge approach is recommended to deal with any minerals carried in solution in drain water exiting the drainage mat gap.

Photograph 9 shows two drip edges at the balcony perimeter edge. The upper drip edge sheds water flowing over the edge of the concrete topping. The lower drip edge sheds water from the drainage mat gap on the top of the waterproofing membrane under the concrete topping. This two-stage drip edge approach is recommended to deal with any minerals carried in solution in drain water exiting the drainage mat gap.
